SPRING 2004

Flight

Comment

THE CANADIAN FORCES FLIGHT SAFETY MAGAZINE

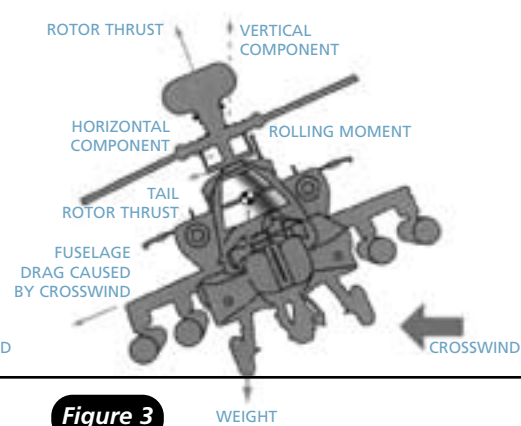
Figure 3

As every student knows, the classic situation that causes rollover is when one wheel or skid is either trapped or stuck to the ground by mud, ice, tie-downs or anything else which can manage to lash one side of the undercarriage to the surface. In this case, the helicopter pivots around the fixed anchor point, in the manner of a hinge, until the rotor blades come into contact with the surface.

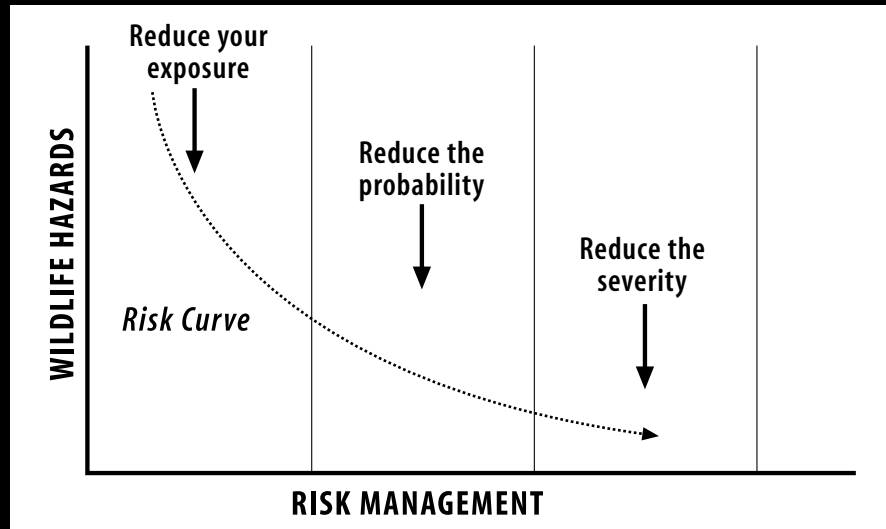
By using a risk management process, it is possible to see more clearly how the risk of bird strikes can be reduced. As the graph below indicates, reducing the exposure to the bird hazard will achieve the greatest reduction in risk.

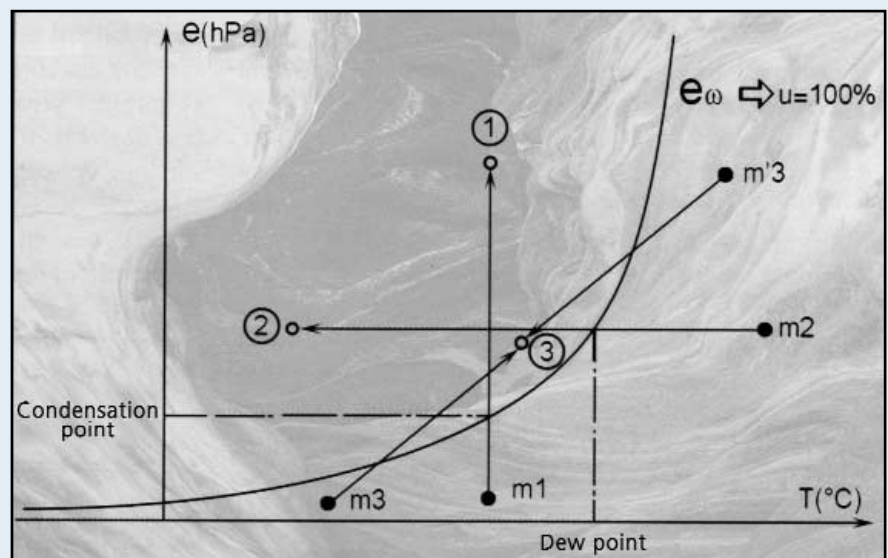
Figure 1: Process of fog formation

- Evaporation. Water in liquid form (e.g. at the surface of a lake) evaporates and raises the partial pressure of the water vapour in the air above it. Condensation occurs and fog forms as point M1 (see Figure 1) crosses curve EW along the path indicated ①.
- Cooling. A very moist air mass, point M2, on the gas side of curve EW, cools and causes the water vapour to condense into fog along the path indicated ②.
- Mixing. In this process, two moist air masses, represented by points M3 and M'3, combine. The air masses are almost saturated and at different temperatures. As a result of the mixing of the air

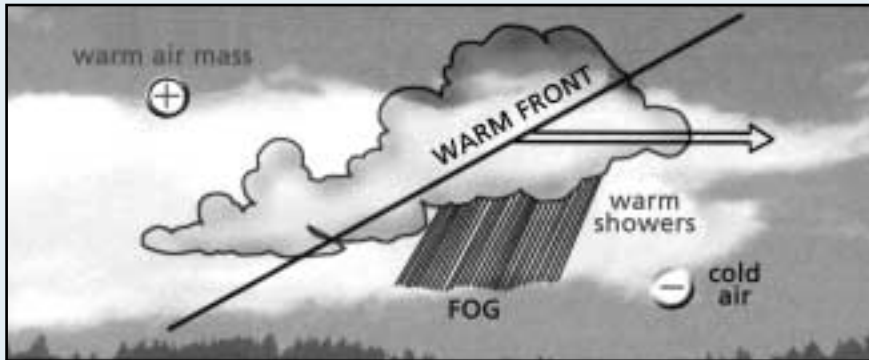
Figure 2: Example of frontal fog

Favourable weather patterns and features: Favourable weather conditions can occur in fall or winter, when a disturbance penetrates a cold continent. Frontal fog forms under the following conditions:

- the temperature of the cold air is markedly colder than the temperature of the warm air,
- the pressure gradient is weak, and
- the surface of the front is close to the ground.

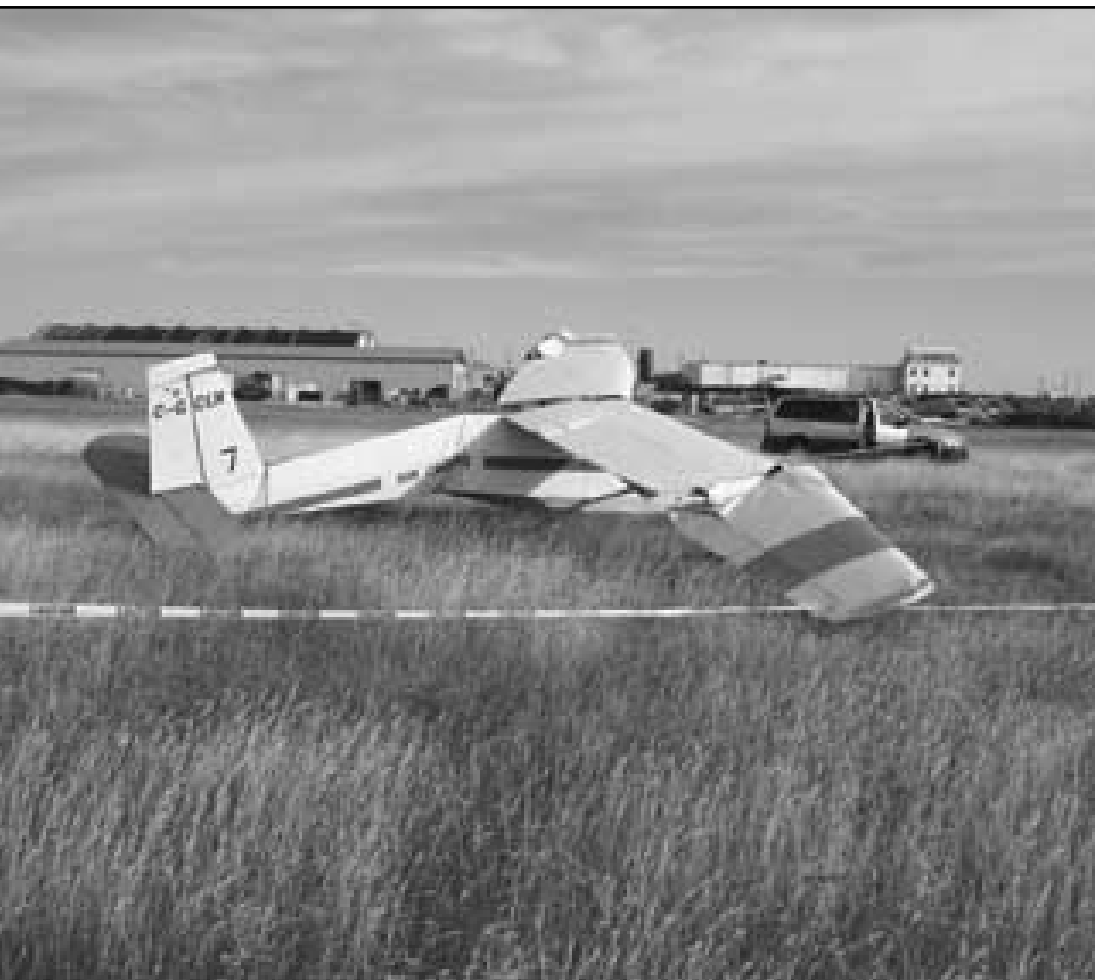
IP then attempted a right 180° turn to position into wind beside runway 28. The glider had nearly completed the turn when the right wingtip impacted the ground. The glider sustained "A" category damage and the IP received minor injuries.

At launch time, the airport Unicom reported winds to be 250° at eight knots, gusting to 15 knots. Although the Launch Control Officer (LCO) heard the Unicom report, the nearest windsock indicated little wind. Additionally, based on his local area knowledge, the LCO knew that winds reported by both the launch site and the Unicom often differed. Although a hand-held anemometer was on site, the LCO, who was confident in his assessment of the winds being less than five knots, chose not to use it. Because the Unicom's wind measuring equipment was elevated higher than both the LCO and his reference windsock, it was able to register the stronger winds aloft. The consequence of this inaccurate pre-launch wind assessment was that the glider encountered decreasing performance shear as it climbed out on tow.

As a result of this accident, all downwind launches to position gliders for operations were prohibited in the Atlantic Region until the completion of this investigation and training was given to all Atlantic Region Site Supervisors about the hazards of low-level turns. Additionally, it was recommended that an accurate quantitative wind measurement, as well as an assessment of winds aloft just prior to the first launch of the day, be made a requirement; the practice of downwind takeoffs be reviewed; and consideration be given to providing Human Performance in Military Aviation (HPMA) training to Site Supervisors.

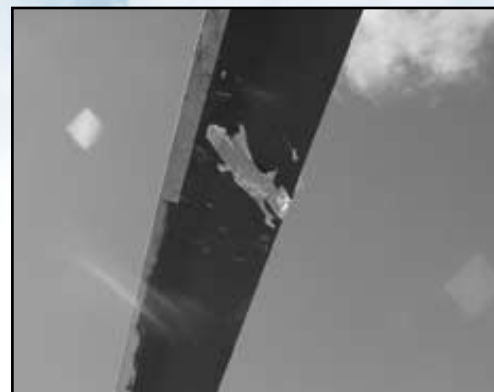
Once at altitude the JM again opened the left cargo door while the Flight Engineer (FE) opened the right one. The parachutists then successfully exited the aircraft and established good chutes before the pilot initiated a left descending turn at approximately 80 knots, and the Flight Engineer (FE) closed the right cargo door. As he reached over to close the left cargo door, two loud bangs and a jolt were felt by all the aircrew. The FE simultaneously observed the left cargo door depart the aircraft.

With an in-flight check determining no damage to any systems or controls, the aircraft landed without further incident at the Valcartier Heliport. Post shut-down, the crew found that all four main rotor blades were substantially damaged.

This aircraft suffered "C" category damage. The investigation is focussing on the rigging of the cargo door assembly. ♦

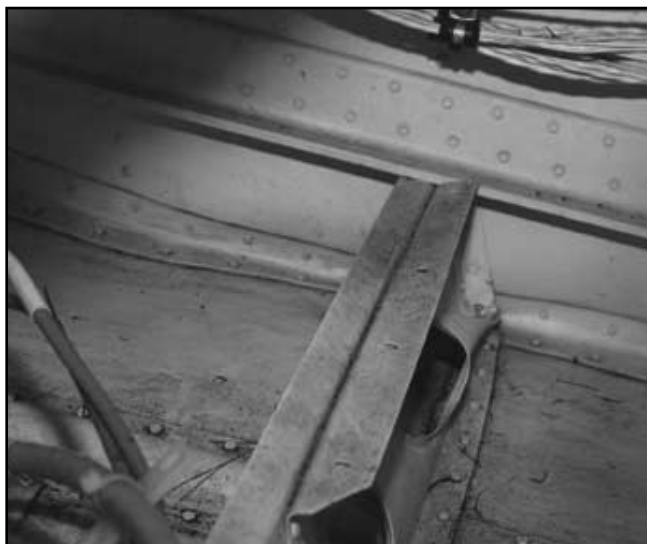
In reality, the landing surface was frozen muskeg. The FO landed gently and performed a seating check in accordance with CH146 Standard Manoeuvre Manual. A few seconds later, the aircraft settled down approximately 12 inches with a 5 degree left roll. The FO immediately increased power to prevent further settling, and the AC took the controls.

Not realizing that the aircraft had now moved forward slightly and that the left skid toe was caught under the ice surface, the AC increased the power further. Full aft and right cyclic input was reached before the aircraft finally broke free and stabilized in a four-foot hover.

Following shut down, damage was found on the underside of the Griffon and consisted mainly of pushed up skin and web damage forward of the tail boom attachment bulkhead. The damage was initially assessed as "B" Category damage. The damage Category was later downgraded to "D" Category following final disposition. ♦

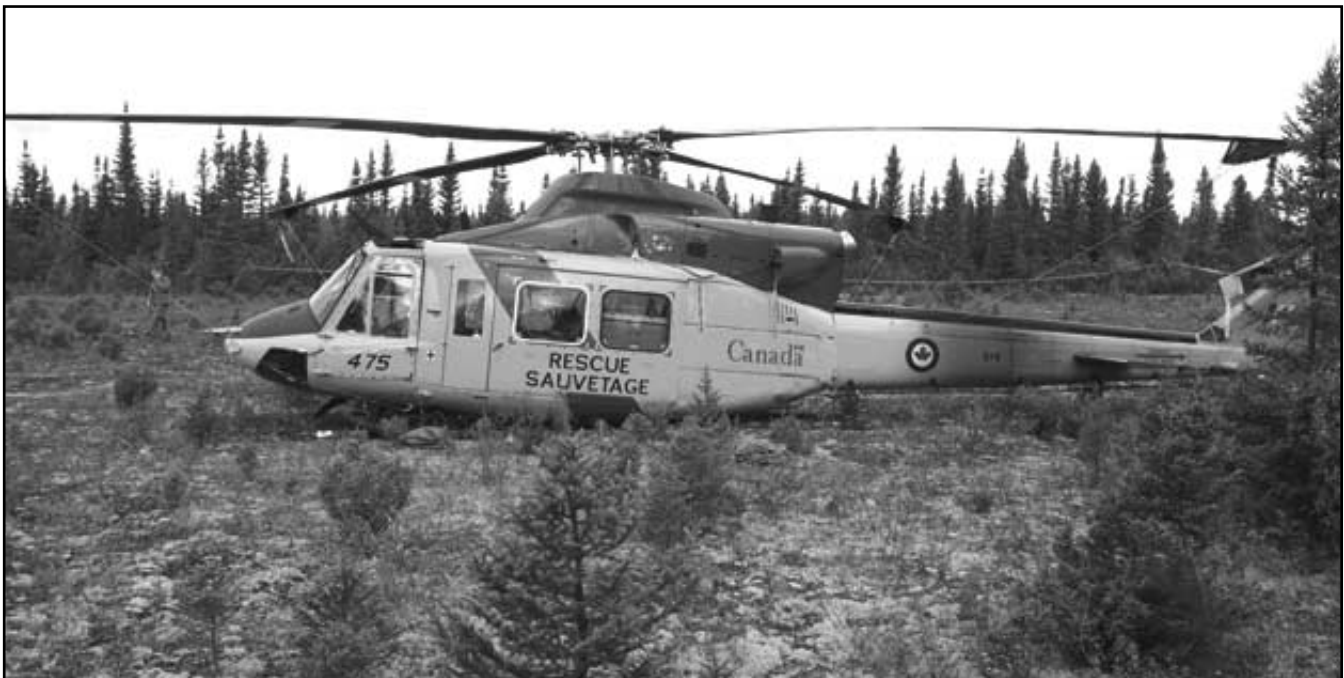
that a tail rotor loss had occurred. Without power to the rotor, the aircraft descended rapidly and despite full collective application, the aircraft impacted the ground with a force of about 5 to 8 g. The aircraft landed in a flat attitude and, while still intact, the received severe damage consistent with a “B” category accident.

Post-crash investigation showed the hoist and Stokes litter still in the full up position, and the non-flying pilot confirmed he did “make and hold” a switch on the right-hand (RH) collective. The next (lower) switch on the RH collective is the rotor RPM governor (beep) switch. Full down “Beep” will reduce the main rotor RPM to about 97%, the same rotor RPM value that the flying pilot noted as he rolled the throttles off. Investigators examined the rotor RPM governor actuator for position, and found the actuator in the full “beep” down position. Of note, the helicopter is fully controllable at 97% RRPM.

Further investigation will focus on autorotation training for CF helicopter pilots, with emphasis on hover autorotation recoveries. The flying pilot had not completed an autorotation from hover to touchdown for 5 years, other than in the simulator. Also, an examination of the human factors associated with the accident will be undertaken. ♦
